EL CAPITOLIO San Juan, Puerto Rico

Services Provided
Conditions Assessment

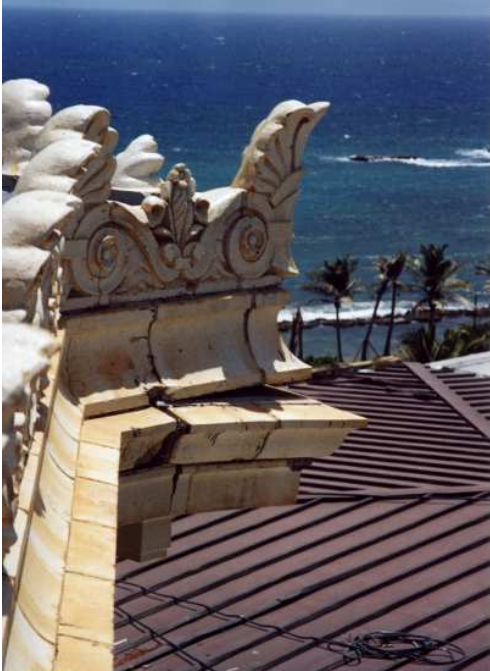
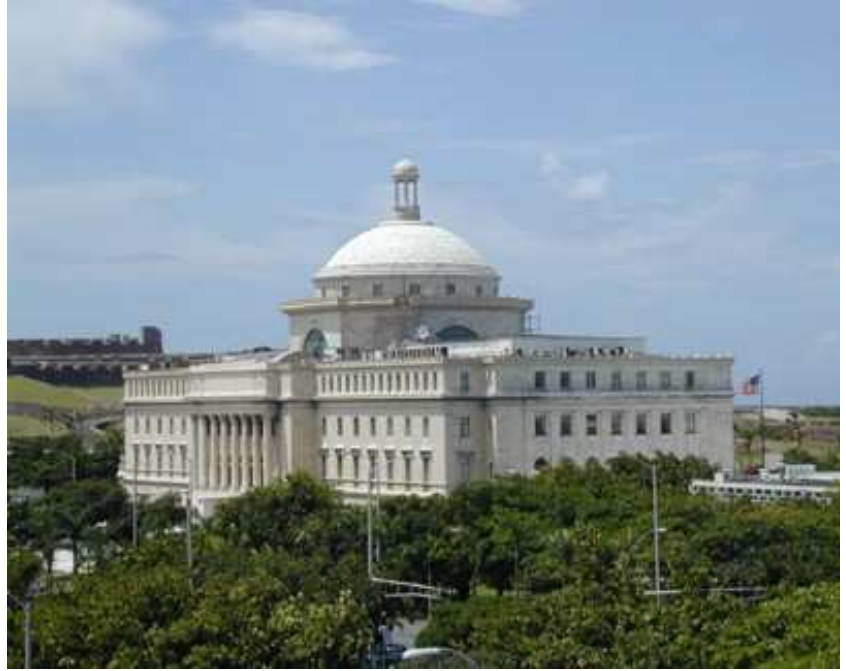
Conservation Solutions, Inc. (CSI) was contracted by the government of Puerto Rico to assist a local architect in the investigation of the main terra cotta cornice located at the base of the dome of El Capitolio. CSI performed investigative work and partial disassembly of a six-foot section of the cornice in order to prevent its collapse and to determine the cause and nature of the failure. CSI also worked to gain a better understanding of the materials and techniques used in its construction and to provide the architect with various repair solutions and assistance with the creation of bid documents.

The investigation revealed several major problems which were all related to the ingress of large quantities of salt-laden moisture. It was recommended that all heavily damaged and collapsing areas of the cornice be dismantled and rebuilt using high quality matching new units from a well-established terra cotta manufacturer. In order to retain as much original material as possible, it was also recommended that the undamaged but unstable areas of terra cotta be stabilized in-situ using the Cintec anchoring system.
