## ROOM 139, PENNSYLVANIA STATE CAPITOL Harrisburg, Pennsylvania

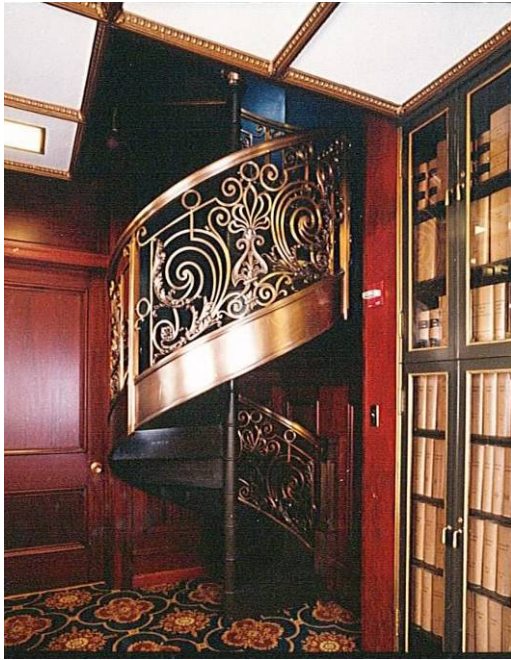
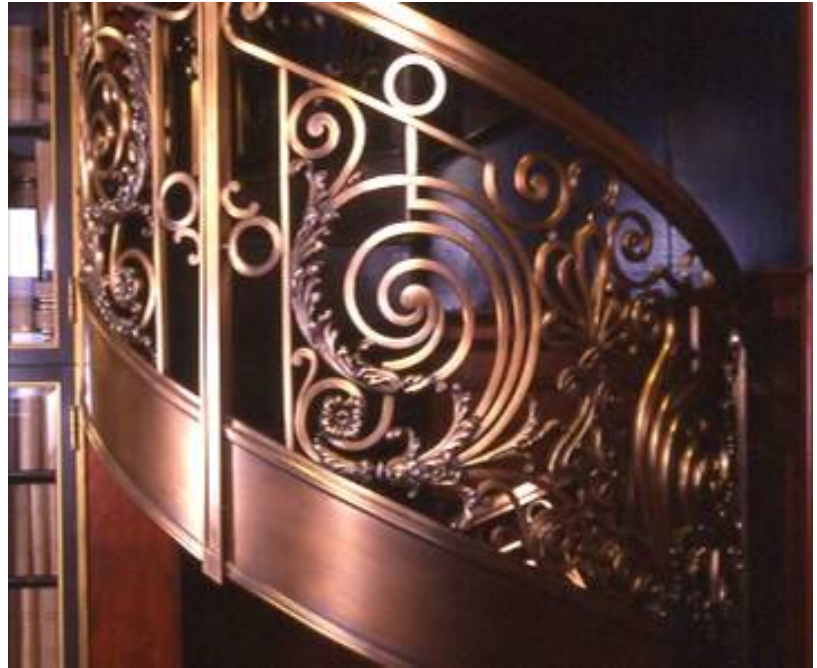
In subsequent decades finishes were applied to the wood elements in the room, obscuring the woodwork's original color. The stunning metalwork (including a bronze spiral staircase and parts of the mezzanine balustrade) was stripped of much of its original surface finish during several particularly insensitive treatments.

When the building was targeted for restoration in 2002, Conservation Solutions, Inc. (CSI) was contracted to act as the supervisory conservator for the metal and woodwork and as the contractor for the conservation of the metalwork. The room's decorative metalwork was restored, including the bronze spiral staircase and mezzanine balustrade. During the restoration of these areas remnants of the original surface finish were found intact. Although the contract specified recreation of these finishes using tinted lacquers, CSI provided the client with a more durable and traditional finish, which included cold patination and burnishing techniques.

The restoration of the woodwork included returning the mahogany wainscot, doors, balustrade, and wood window wells to their original color. A number of dutchman repairs were made to the woodwork, as well as repairs to the 1939-period mahogany swinging gates.
