ROMANESQUE FOUNTAIN The Biltmore Estate, Asheville, North Carolina

Client/Owner
The Biltmore Estate

Project Dates
2006

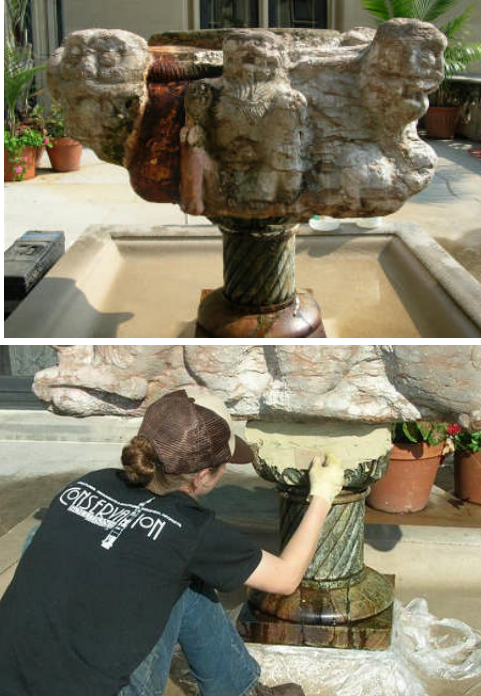
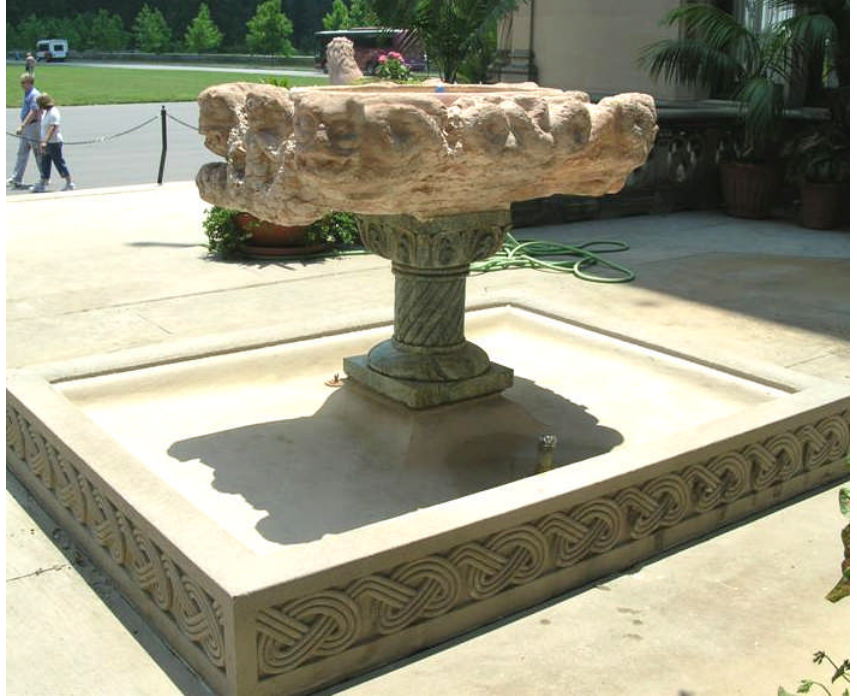
As part of our on-going work with Biltmore Estate, Conservation Solutions, Inc. (CSI) was contracted to conserve the marble Romanesque fountain located at the entrance to the mansion. The marble fountain is constructed of a carved basin of *Rosso di Verona* marble, a verigated pink marble, a pedestal base of green marble, and a limestone splash basin. The carvings depict the likenesses of lions and serpents. Water flows over the lip of the basin and runs through the time-worn surfaces between the animals and into the limestone splash basin.

CSI conservators worked with the Biltmore Estate's conservation staff to clean and restore the fountain. The focus of the treatment was to remove surface soiling, biological growths and staining, reverse and remove failed previous fills, and repair a large loss to the lip of the pink marble basin which caused the water to flow preferentially over the back side of the basin.

All surfaces were cleaned using appropriate detergents and biocides. Biological growths were further removed by careful picking with wooden skewers. The lip was repaired using a custom colored mortar. The extensive iron staining on the green marble pedestal was removed with multiple applications of poultice. Maintenance recommendations were provided and Biltmore staff were trained in the procedure to regularly treat the basin with a biocide to reduce the recurrence of biological growth.
