RENAISSANCE WELLHEAD The Biltmore Estate, Asheville, North Carolina

Client/Owner
The Biltmore Estate

Location
Asheville, NC

Project Dates
2006

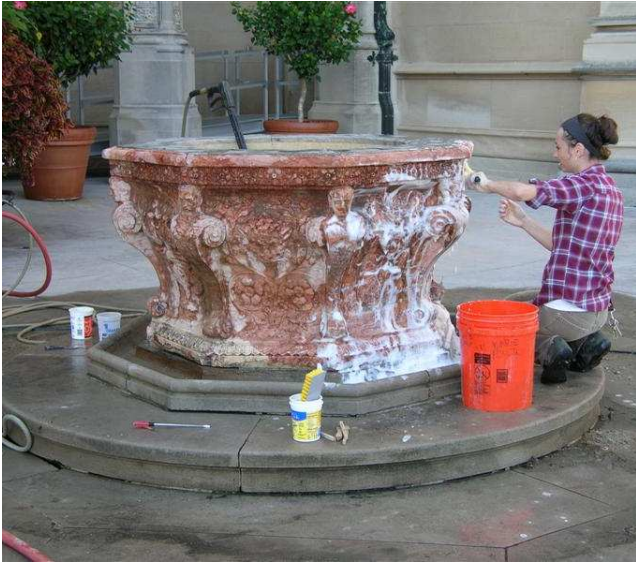
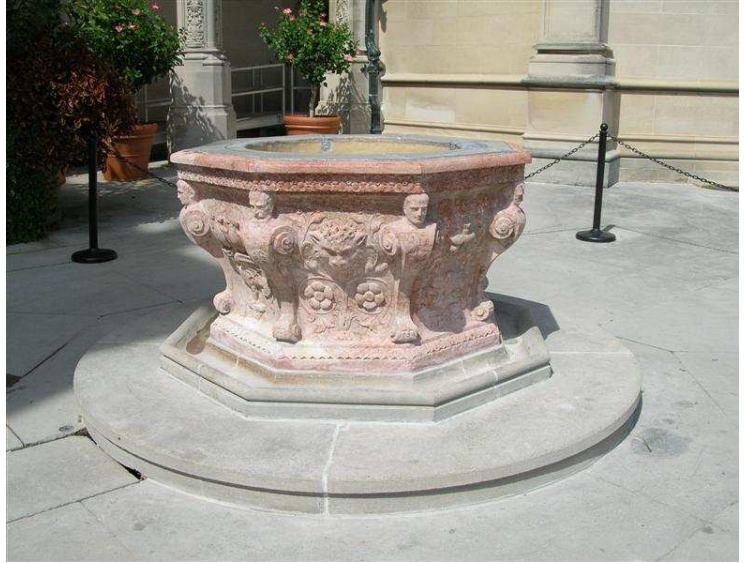
The wellhead had developed deterioration typical of outdoor masonry artifacts since its installation at the estate. Water had entered failing mortar joints, opening them over time though freeze/thaw cycling. Early repairs had failed leaving losses and additional water entrapment points. The solder joints had also given way within the basin. Biological growth, lime scaling, and general soiling hid the beautiful carvings on the faces.

CSI conservators worked with the Biltmore Estate's conservation staff and specialty sub-contractors to clean and restore the wellhead. Failed mortar and fills were removed. All surfaces were cleaned using appropriate detergents and biocides. Biological growths were also removed by careful picking with wooden skewers. The lead liner was cleaned and re-soldered. Failed fills were repaired with custom color-matched mortar and all joints were re-pointed. A follow up treatment plan was developed for implementation by the Estate's staff
