## CARSHALTON GATES Oyster Bay, Long Island, New York

**Client/Owner**  
New York State Dept. of Parks  
and Historic Preservation

**Services Provided**  
Rigging/Transport  
Paint Analysis  
Structural Repairs

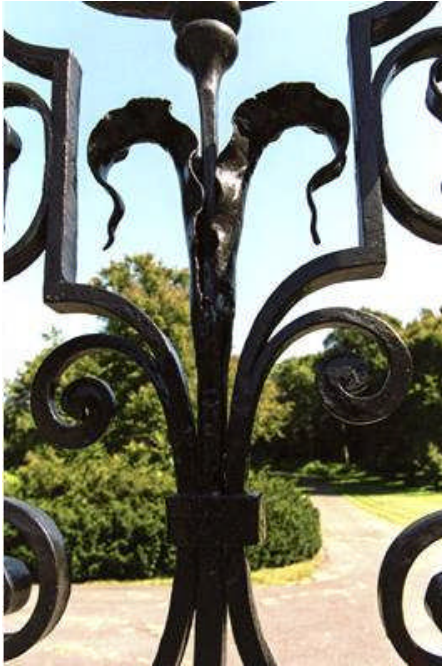
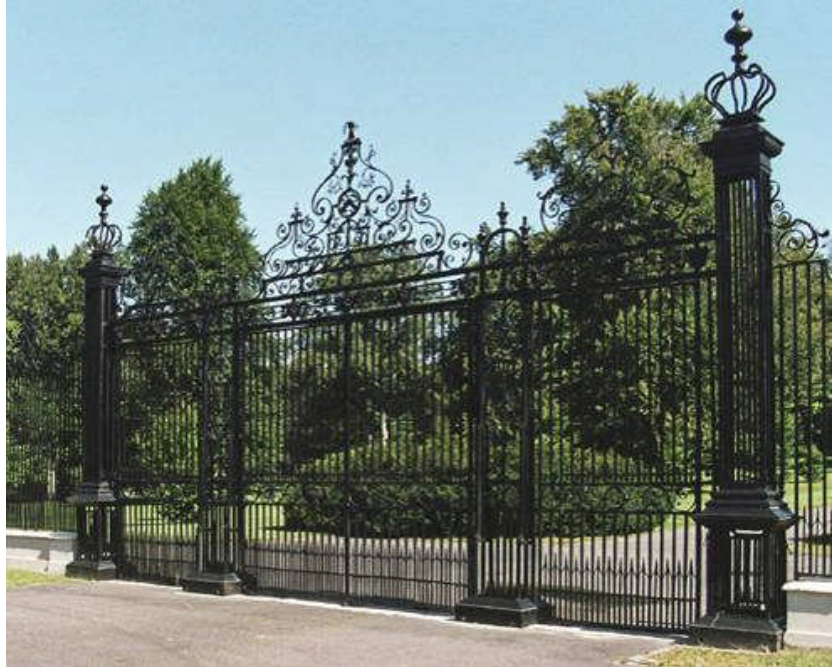
Each element was stripped of existing coatings and assessed for damages and necessary repairs. Most losses were associated with entrapped water which led to rust formation. Work was divided into unit replacements, in-kind repairs and synthetic fills. Skilled craftsmen repaired losses in keeping with the original design and assembly details while removing water catch points. At the completion of the restoration, the gates were again cleaned and metalized before being coated with a high performance paint system. They were transported to the site and installed atop the restored stonework at the completion of the work.

Conservation Solutions, Inc. (CSI) completed the restoration of the Carshalton Gates between 2003 and 2004. The gates were thoroughly documented before being removed from the site. Careful measurements were taken to assure that the gates could be reinstalled after restoration. A paint analysis was done prior to treatment to determine the original paint color and scheme.
