## CHARLOTTE MILLER MONUMENT University of Virginia Cemetery, Charlottesville, VA

**Services Provided**  
Repair  
Support Frame  
Conservation  
Documentation

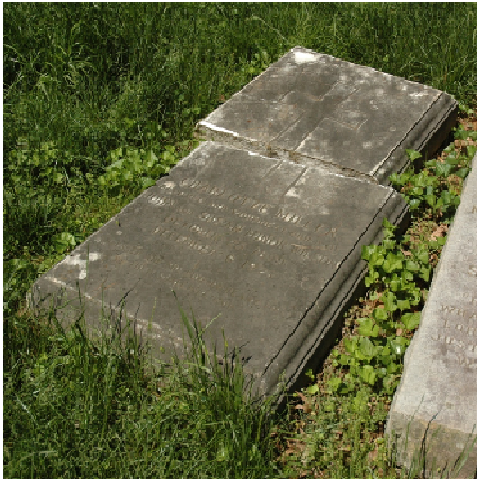
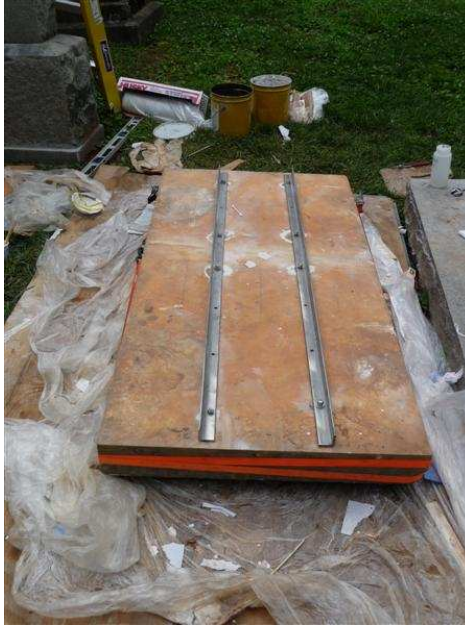
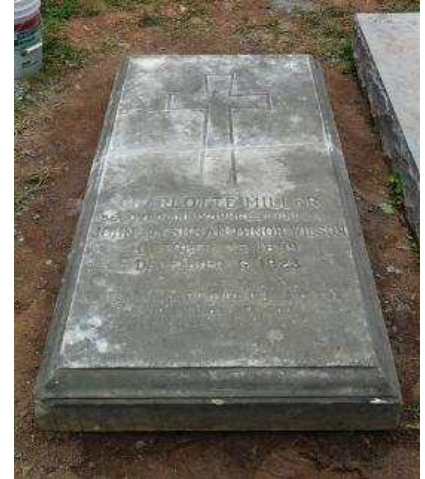
Founded in 1828, the Cemetery at the University of Virginia has served as the final resting place for many of the most prominent figures of the University. Burials of those who taught or were associated with the University have continued to this day. Moss covered headstones of marble and granite rest within mature stands of old growth trees inside the cemetery's stone wall enclosure. Long term erosion of the soil around headstones, markers and the old growth trees have put these monuments at risk. The fall of one of those trees in 2008 caused extensive damage to a number of the stones in the cemetery, including the white marble table stone of Charlotte Miller.

Working with staff from the University, the large table stone was carefully turned over onto its face onto a stable surface. The faces of the break were aligned, dowelled together with stainless steel pins set in epoxy and the fracture faces adhered with a lime-based adhesive. To provide additional support before righting the stone, two heavy gauge stainless steel angles were attached using a small quantity of stainless steel pins to the back face of the stone.

The table stone originally set on two footing blocks which were out of plumb. The bed was leveled in accordance to the existing pitch using gravel and soil. The stone was then righted and the angle irons were set level (side to side) with a slight pitch (top to bottom) to match the adjacent table stones. The face of the stone was only lightly cleaned with water to remove excessive soiling and the fractured edge was repaired with lime-based materials. Recommendations were provided for soil erosion control and monument maintenance.
