CAST STONE SURROUNDS Miami Beach Community Church, Miami Beach, Florida

Client/Owner
Miami Beach Community Church

Services Provided
Conditions Assessment
Budgetary Cost Estimating
Restoration Plan

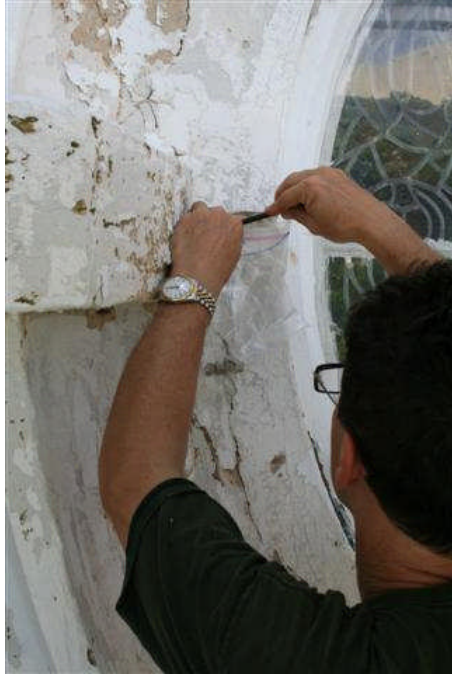
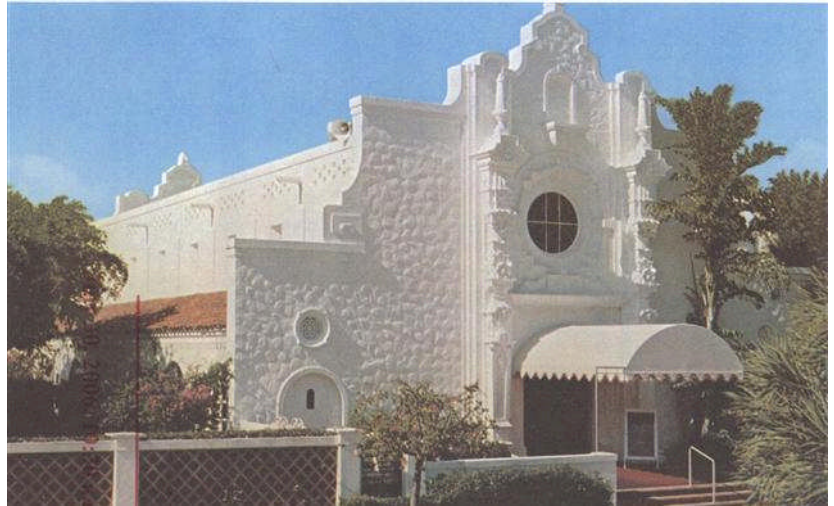
More than 80 years of exposure to the marine air, punctuated by periods of emersion from hurricanes and floods, lead to extensive damage to the cast stone. The cast stone, intended to resemble the local Coral Stone from which it is cast, was susceptible to both salt exposure and carbonation of the cement paste. The embedded iron reinforcing bars were no longer stable and their rapid corrosion was causing extensive cracking of the decorative elements.

Conservation Solutions, Inc. was contracted by the church to assess the damage and determine a restoration plan. The condition of each block was surveyed and cracks, losses, and deterioration were noted on the Architect's base drawings. Core samples were taken from cast stone units and concrete walls and were subjected to a variety of testing which ultimately revealed sodium chloride salts to be the cause of the deterioration. CSI then developed a restoration plan and budgetary cost estimate for the recommended work. The church is currently raising funds towards implementing the treatment.
