**CAST IRON BANDSTAND** Victoria Park, Hamilton, Bermuda

**Client/Owner**  
The Corporation of Hamilton

**Services Provided**  
Assessment  
Documentation  
Treatment Recommendations

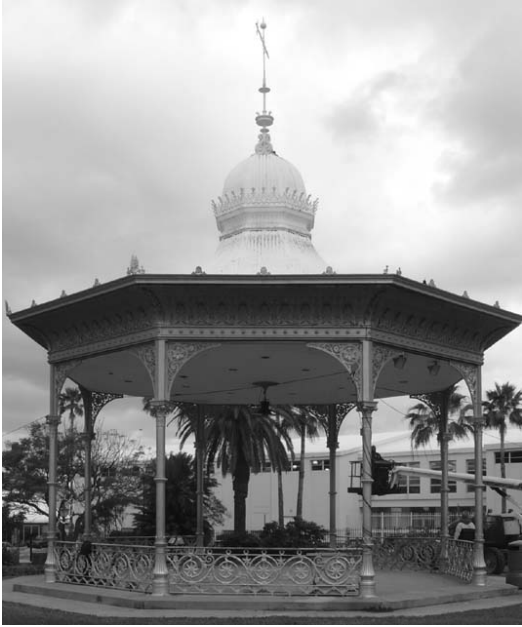
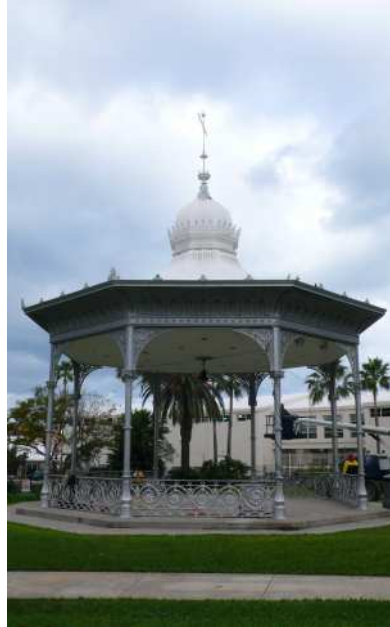
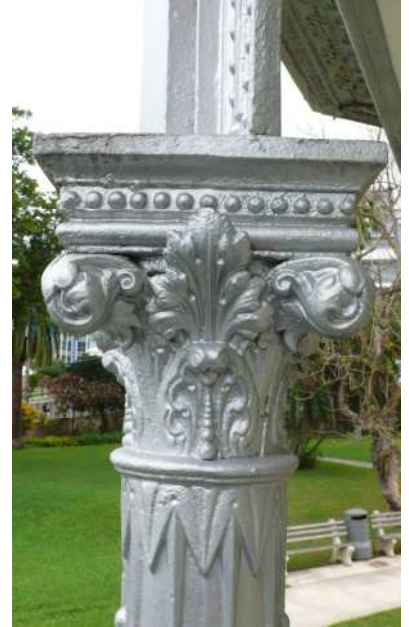
Nevertheless, over 100 years of exposure to the marine environment and hurricanes have taken their toll on the structure. Over 11 layers of paint were found on the roof panels, which still had suffered extensive loss from corrosion. Several decorative railing panels had been removed and lost. Other decorative elements had cracked or been broken from stresses or impact. Well meaning but misguided maintenance and improvements had raised the grade of the concrete deck and replaced the original heart pine ceiling with gypsum board. Electrical services and drainage were not functioning as desired.

Conservation Solutions, Inc. (CSI) was contracted by the Corporation to assess the Bandstand and develop a treatment plan in 2008. The entire structure was surveyed and documented. Measured drawings were prepared of all elevations and sections to assist in describing the observations and quantifying the work. Details were also noted on annotated photographs in a written assessment report. A budget for the work was prepared and submitted to the client.
