VIZCAYA BACCHUS FOUNTAIN Vizcaya Museum & Gardens, Miami, Florida

Services Provided
Assessment
Documentation
Treatment

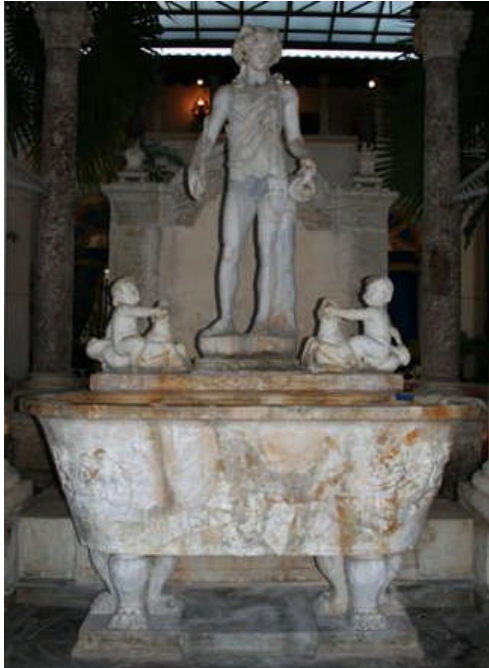
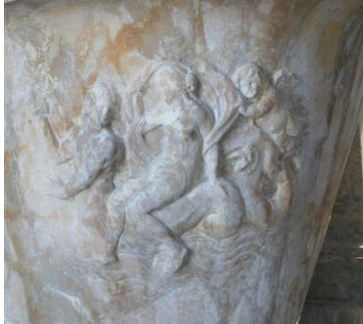
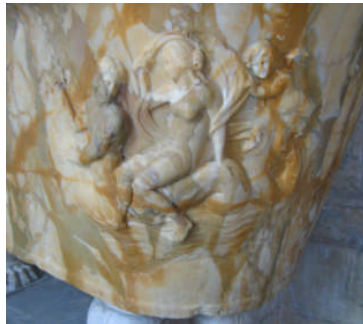
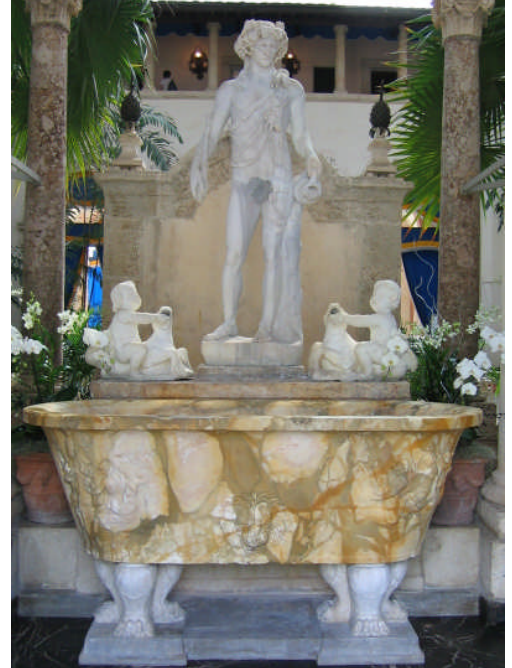
Nearly 100 years of use had taken its toll on the fountain. The putti and figure were soiled and previous repairs had begun to fail. Regular floor maintenance had damaged the verd antique pool lip. The color and detailing of the yellow marble basin was entirely hidden by a whitish haze from hard water deposits from the water that flowed across its surface.

Conservation Solutions, Inc. (CSI) was contracted to restore the fountain in 2007. After careful detergent cleaning to remove soiling, the failing fills were replaced with appropriately formulated lime mortars. The losses in the verd antique pool were rebuilt with color matched scagliola mortars and toned to match the figured stone. The lime deposits were carefully removed by multiple repeated applications of gelled solvents and hand scrubbing. Protective color-enhancing coatings were then applied to protect the stone and a treatment report submitted.
