## RESTORATION OF THE BRONZE HANDRAIL, 44th New York Infantry Monument Gettysburg, PA

**Client/Owner**  
National Park Service Monuments Preservation  
Branch/Gettysburg National Park

**Project Dates**  
2003

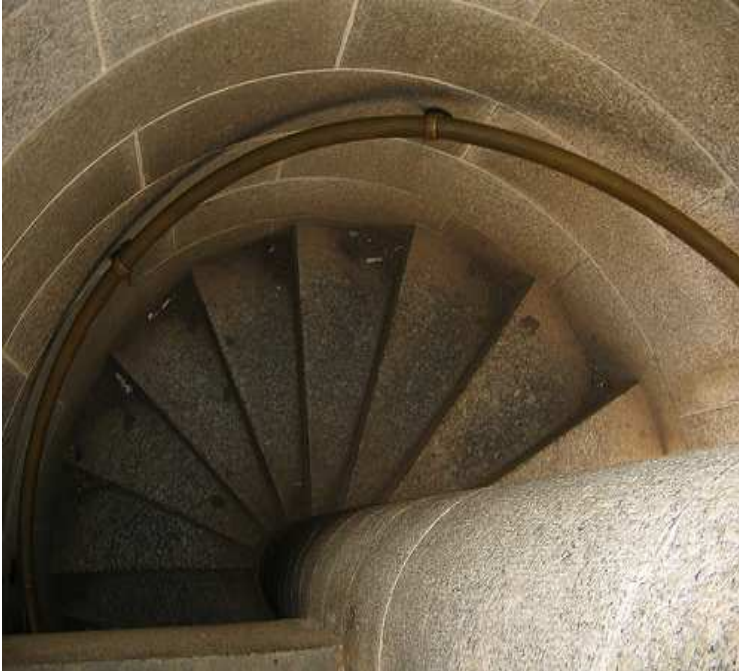
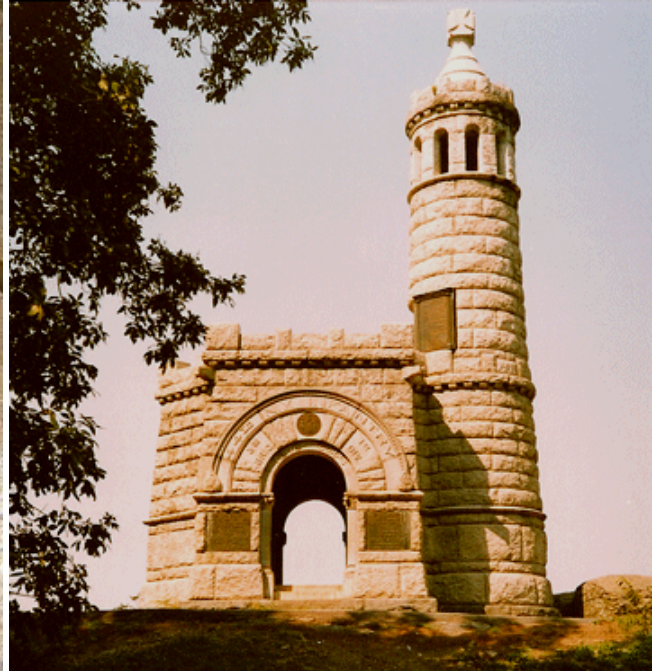
After 100 years of visitors and exposure to Pennsylvania winters the railing had been damaged beyond repair. End pieces were missing, supports had pulled from the walls and the rail itself had split from ice entrapped within. Conservation Solutions, Inc. (CSI) conservators were contracted by the National Parks Service to replace the damaged railing. After documenting the conditions, CSI removed the railing, salvaged the original mountings, created new mounts and end caps, bent and formed a new rail, patinated all of the new elements to match the historic originals, and remounted the railing in the original location. Bending and fitting the continuous railing to match the sloping curving stair was particularly challenging as most of the shaping had to occur on-site.
