DECORATIVE BRONZE MOCK-UPS, National Academy of Sciences, Washington, DC

Client/Owner
Quinn Evans Architects
National Academy of Sciences

Services Provided
Assessment
Treatment Mock-Ups
Photo-documentation
Treatment Recommendations

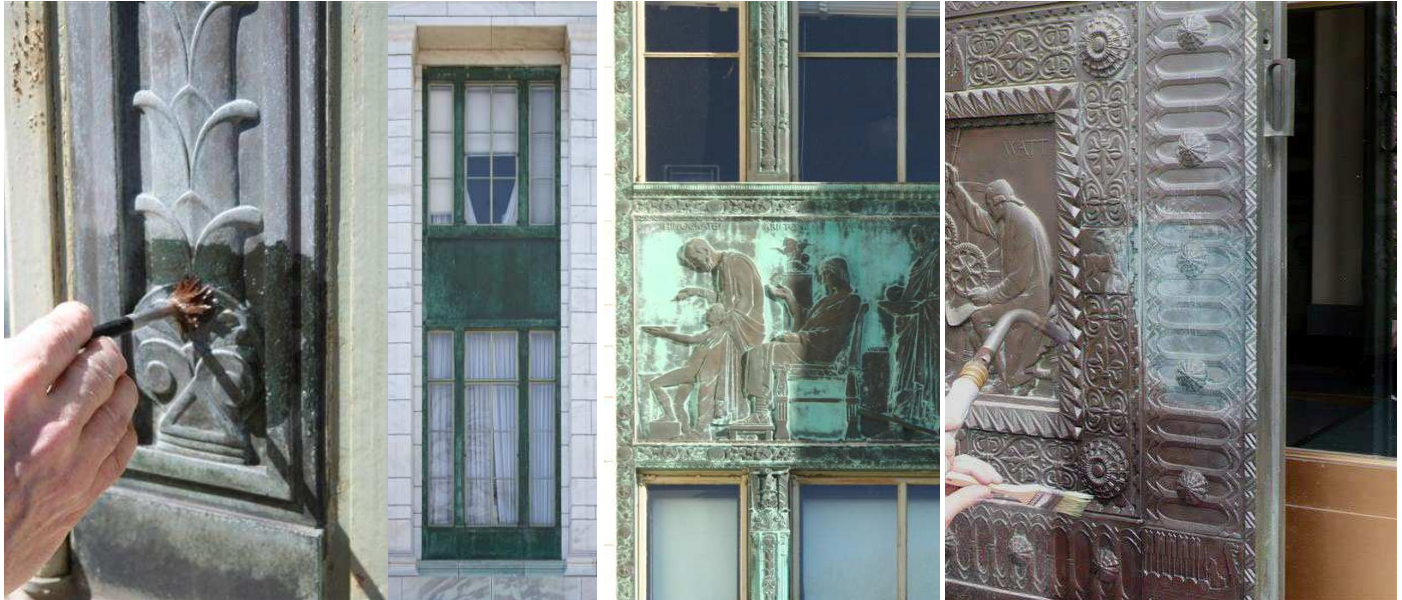
However, after decades of exposure, exterior bronze patinas had begun to degrade or fail. Several additions to the building in the 1960s-70s left the building-wide decorative scheme looking inconsistent. Previous efforts to clean and/or selectively re-patinate metals significantly disrupted the extant finishes. An obvious faux finish on interior grilles left the client wondering if the metalwork was even bronze.

Conservation Solutions, Inc. (CSI) was contracted in 2009 to perform a finishes investigation and mock-ups. A variety of tests were performed to identify original finishes, demonstrate refinishing options, and generate treatment recommendations. Paint was carefully removed layer by layer from interior grilles to determine the sequence of finishes present. Multiple patina samples were prepared on exterior bronze, using both hot and cold chemical applications. A variety of protective coatings, including waxes and lacquer were also illustrated. CSI synthesized information gathered through research, historic documentation, testing, and in-situ mock-ups into a conservation assessment report which made recommendations for replicating the finishes and also included budgetary cost estimates to implement the work.
