PEACOCK COLUMNS Vizcaya Museum & Gardens, Miami, Florida

Client/Owner
Vizcaya Museum & Gardens

Services Provided
Salvage
Disassembly
Conservation Treatment
Replication
Documentation

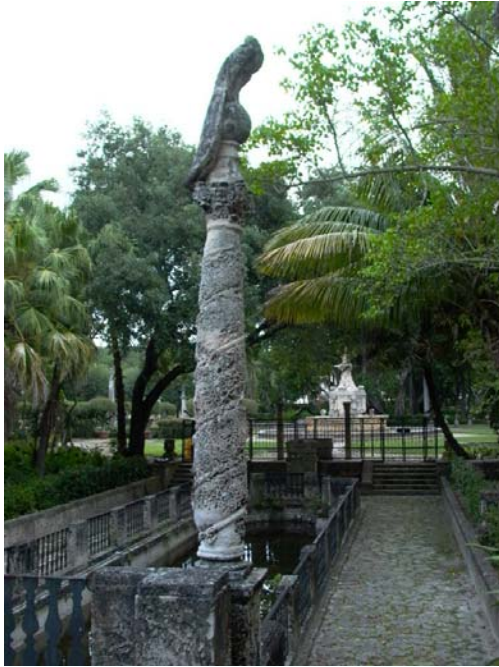
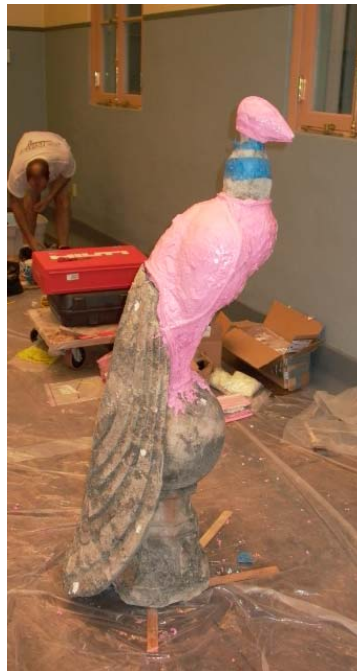
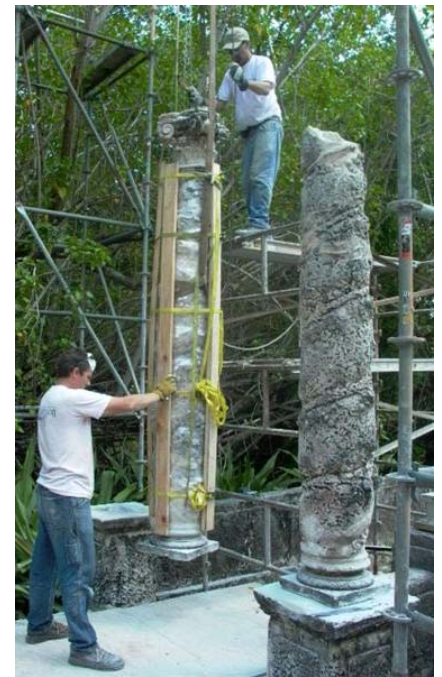
The sculptures had been repeatedly damaged by the frequent hurricanes that plague the bayside location. All had been damaged and repaired at least once in the past. Half of the columns were dismantled and further damaged when the garden site was reduced in size prior to the creation of the museum. Previous inexpert repairs had masked the original elegant designs. The columns were poorly supported and any upcoming hurricane threatened catastrophic damage.

Conservation Solutions, Inc. (CSI) was contracted by the museum to remove and salvage the remaining columns and sculptures. After erection of structural scaffolding, each sculpture and column was carefully removed from its column, hoisted, and transported to secure storage. After careful research, the intact remnants of the peacocks were molded and plaster replicas were created from the fragments. These plaster replicas will be used to create replacements when the garden columns are restored.
