GRAVE MARKERS and MONUMENTS, Charleston, SC

Client/Owner
St. Mary's Parish Church

Services Provided
Conditions Assessment
Treatment
Documentation

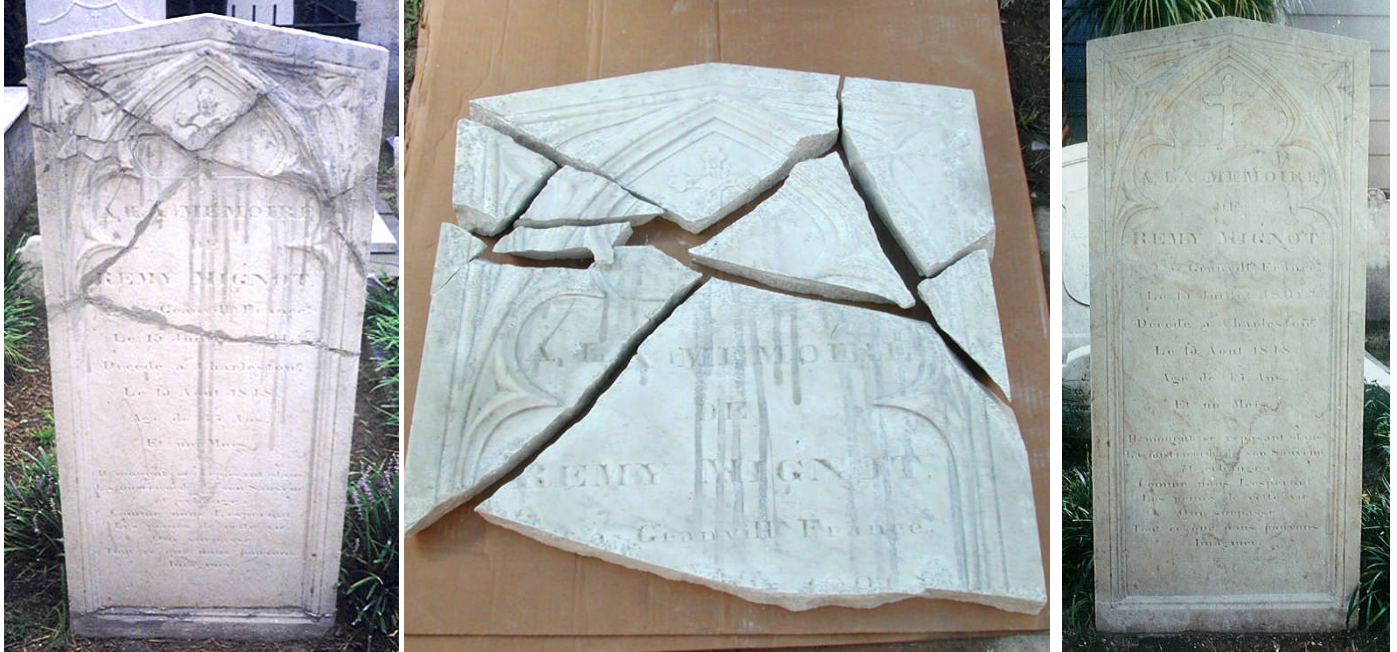
Conservation Solutions, Inc. (CSI) was contracted to perform a conditions survey of more than three-hundred grave markers and monuments located in the church's cemetery, and to conserve seven grave markers that had been broken by a previous contractor during a restoration effort. The broken markers had been improperly repaired with a hard Portland cement patching material. Many of the various broken pieces were misaligned before reattachment and excess patching material was allowed to drip over the faces of the stones. The excess material was not removed before it cured and thus adhered to the marble substrate.

CSI initiated treatment on the broken and improperly repaired grave markers by removing the inappropriate repair material from the surface of the stone using scalpels and fine chisels and then reassembling the stone fragments in proper alignment using Jahn Restoration Adhesive. Any remaining cracks or losses were filled with custom-matched fine lime putty.
