THE DEPARTMENT OF VETERANS AFFAIRS BUILDING BALUSTERS Washington, DC

Client/Owner
General Services Administration (GSA)

Location
Washington, DC

Services Provided
Conservation Treatment

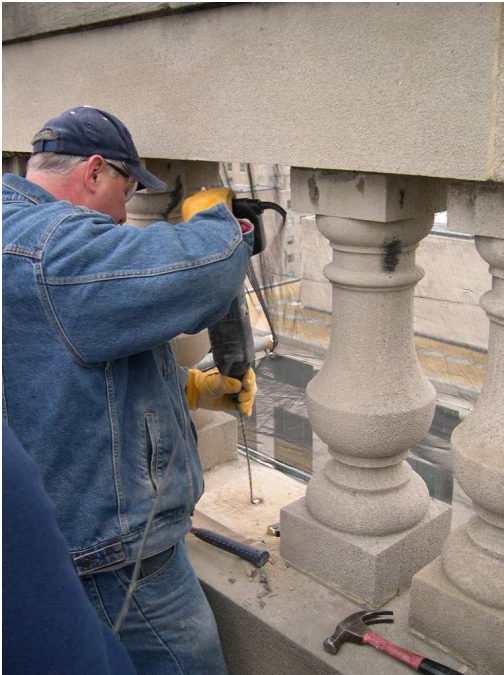
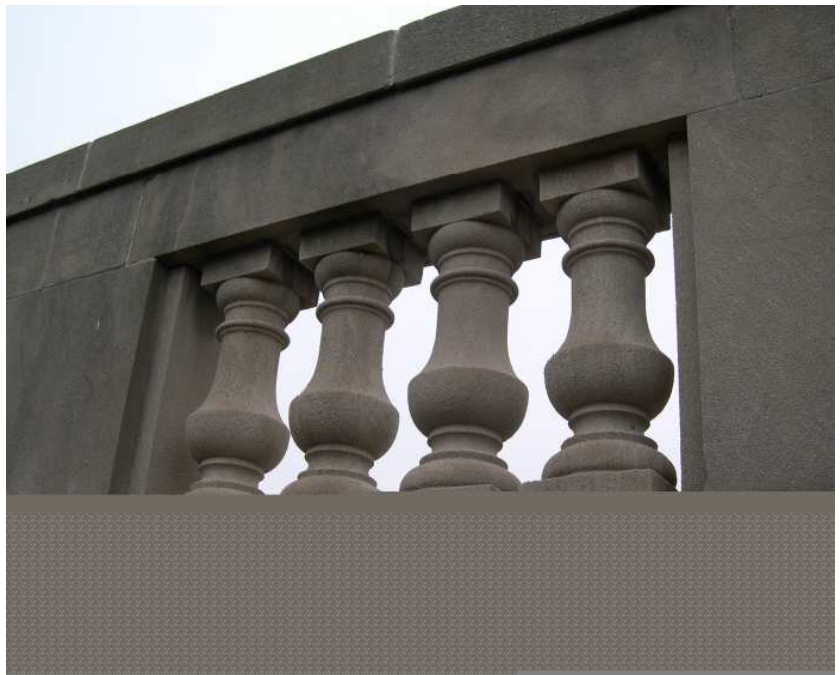
Iron pins centered on each of the balusters had deteriorated and expanded, splitting a number of the massive limestone turnings. The most urgent goal was the removal of any life/safety threats posed by the balusters. Each damaged baluster was carefully cut out by raking and saw cutting of the mortar. Next, the sources of the damage, embedded iron pins and failed skyward facing coping joints, were replaced or restored. New limestone balusters, exactly matching the originals, were carved and either replaced in total or fitted to the originals as partial repairs. Restored balusters were then replaced in the parapet using new stainless steel custom fabricated drop anchors. The joints were then painted to match the existing historical mortar and lead caps were installed atop the upper joints to eliminate further water infiltration.
